Fiber-Reinforced PCC Unbonded Overlay I-29 Atchison County – Performance Update

**Research
Development
and Technology
Division**

Missouri
Department
of Transportation

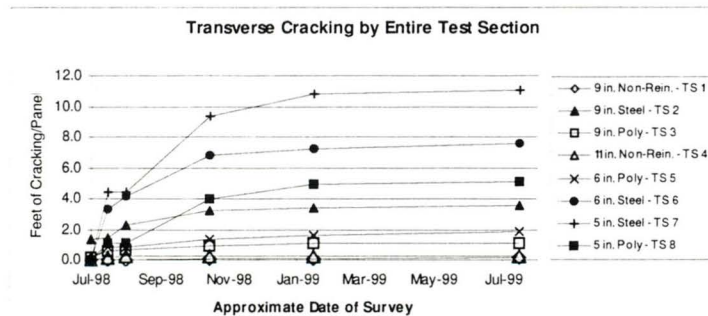
Figure 1 shows the amount of transverse cracking for all test sections. This figure represents the relative amount of cracking in each section. Detailed analysis of the cracking is present in the full report, "Evaluation of Fiber-Reinforced Unbonded PCCP Overlay". Some trends with regard to transverse cracking are apparent. Thinner sections exhibited more cracking than thicker sections; longer panels exhibited more cracking than shorter panels and the steel fiber-reinforced sections exhibited more cracking than the polyolefin fiber-reinforced sections.
